## "Complications after aortic valve repair and valve-sparing procedures."

Van Dyck, Michel ; Glineur, David ; de Kerchove, Laurent ; El Khoury, Gebrine. *Complications after aortic valve repair and valve-sparing procedures..* In: *Annals of cardiothoracic surgery*, Vol. 2, no.1, p. 130-9 (2013)

# Complications after aortic valve repair and valve-sparing procedures

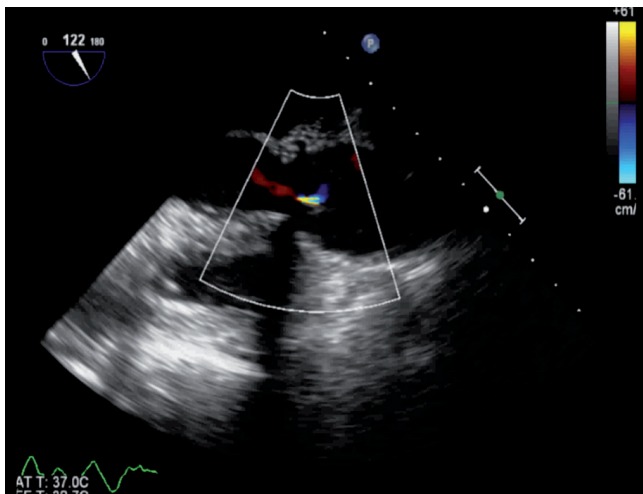
**Figure 1** Transesophageal echocardiographic midesophageal aortic valve long-axis (TEE ME AV LAX) view with color Doppler performed after aortic valve reimplantation surgery, showing mild aortic insufficiency (AI) immediately after release of the aortic cross-clamp. Note that the ECG (green trace) shows ventricular fibrillation. Magnitude of the AI at that moment, with pressure applied by the cardiopulmonary bypass (CPB) flow into the aortic root, is close to the magnitude of the AI that will be observed after CPB separation with normal hemodynamics

Immediately after aortic unclamping, TEE will disclose any residual defect of coaptation. The pressure applied by the CPB flow through the arterial cannula into the aortic root will cause regurgitation into the left ventricle if the repaired cusps do not coapt adequately (10). The severity of the regurgitation at that moment is close to the one that will be

observed after weaning of CPB (*Figure 1*).

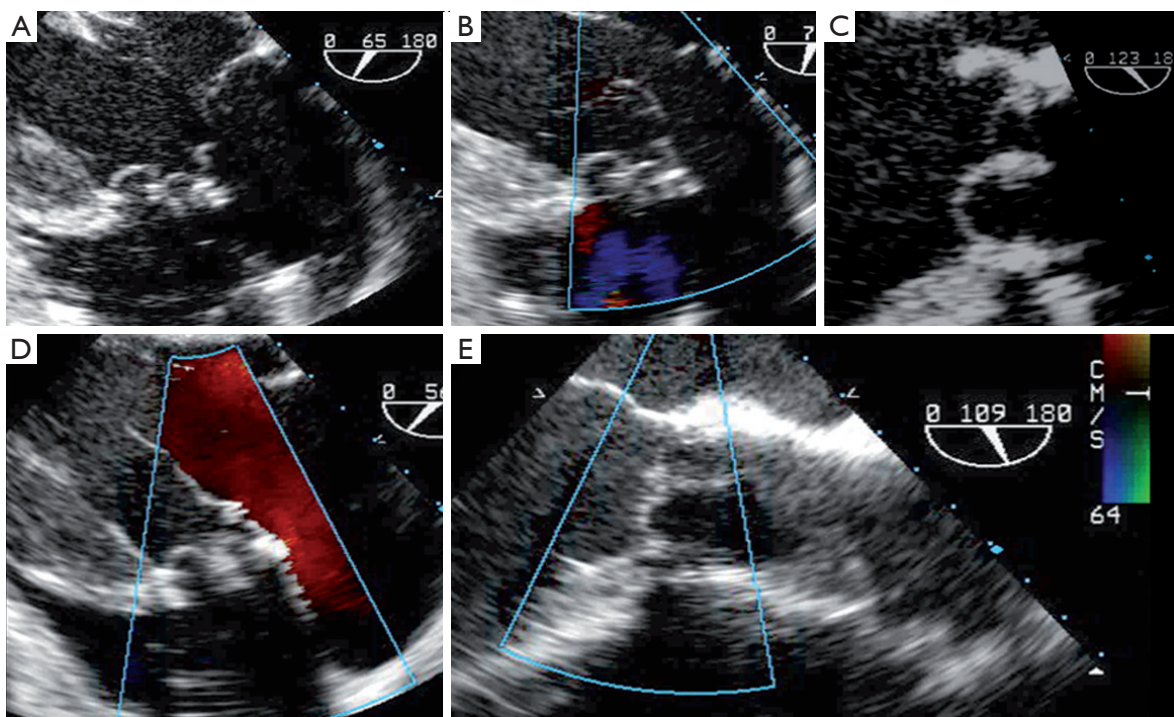
**Figure 2** (A) Transesophageal echocardiographic transgastric long-axis (TEE TG LAX) view, (B) TEE TG LAX view with color Doppler and (C) midesophageal aortic valve long-axis (ME AV LAX) view after repair of a bicuspid aortic valve and reimplantation surgery, showing a short coaptation and billowing of both cusps. Despite the absence of any AI it was decided to go back on pump and to add plication on the margin of the two cusps. (D) ME AV LAX view and (E) TG LAX view after further plication, showing a longer and higher coaptation

It has been demonstrated that the 3 most important parameters for a durable repair are: the absence of any or more than mild residual AI, a coaptation length greater than 4 mm and coaptation starting well above the plane of the aortic annulus (9). The coaptation height is the most important parameter (9,11,12) and can be measured intraoperatively with a special caliper. This effective height (eH) has been shown to correlate with the coaptation length measured with TEE in the mid-esophageal long axis view (13,14). Resuspension of the aortic commissures too low into the tube graft leads to early valve failure (11). Therefore, low coaptation observed after a valve-sparing procedure should prompt the surgeon to go back on pump and further plicate the free margin of the billowing cusp(s) in order to increase the height (15) (*Figure 2*).

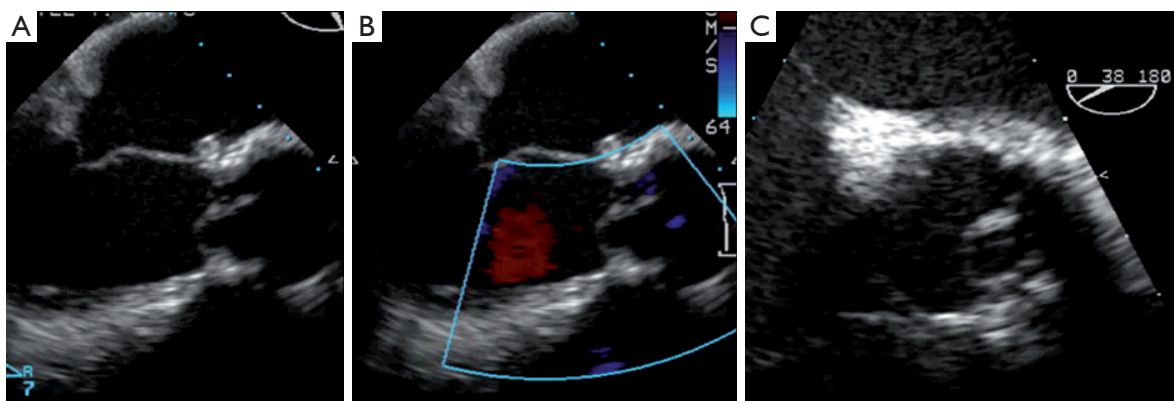
**Figure 3** Billowing of the anterior cusp of a bicuspid aortic valve after repair and reimplantation. (A and B) Transesophageal midesophageal aortic valve long-axis (TEE ME AV LAX) and (C) short-axis (ME AV SAX) view. The billowing portion of the anterior cusp appears circular in the short axis

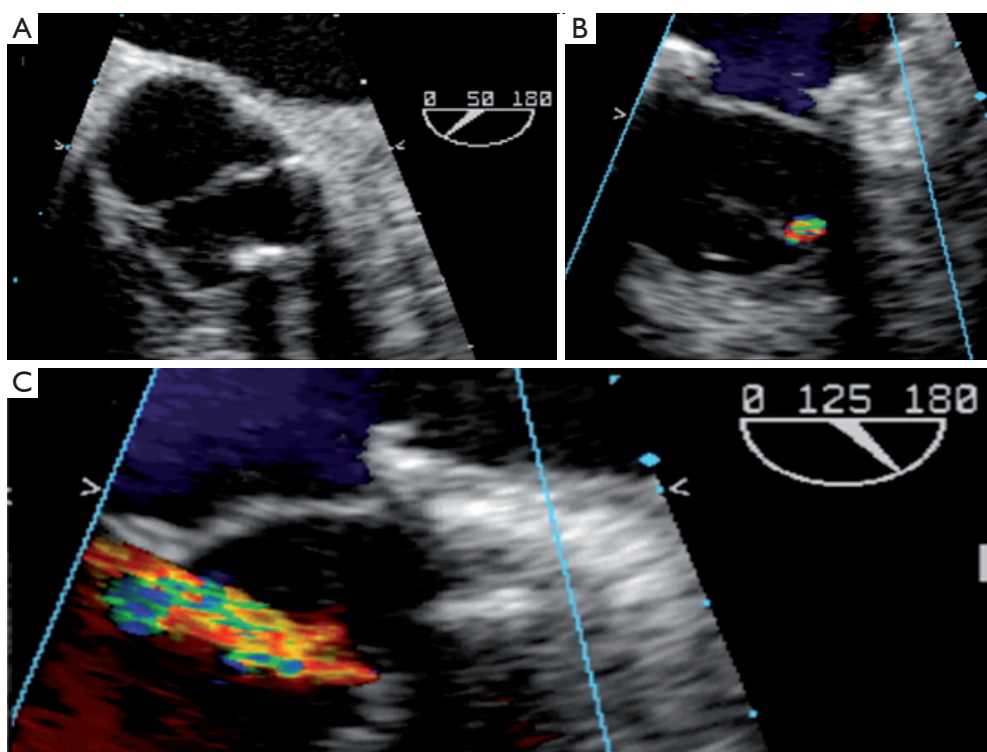
**Figure 4** Calcification of the conjoint cusp of a bicuspid aortic valve. (A) Midesophageal aortic valve short-axis (ME AV SAX) view before repair; (B) ME AV SAX and (C) long-axis (ME AV LAX) views of the aortic valve after reimplantation procedure, showing a residual perforation at the level of the removed piece of calcium

Removal of a fibrotic raphé or a piece of calcium from a cusp can leave a perforation that, if uncorrected, will appear as a residual jet originating both in the short and the long axis from the body of one of the aortic cusps (*Figure 4*). Depending on the size of the perforation, either a direct suture or a pericardial patch can be used for closure.

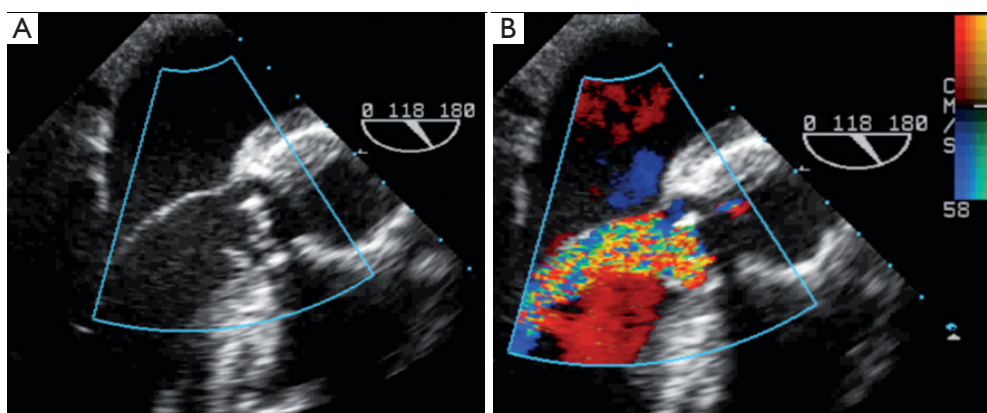
**Figure 5** Midesophageal aortic valve long-axis (ME AV LAX) view showing dehiscence of the autologous tricuspid patch used to repair a bicuspid aortic valve. This complication occurred 10 days after the valve repair, necessitating redo surgery with reattachment of the patch

and repaired the valve with a tricuspid autologous patch. Unfortunately, dehiscence of the patch occurred in the early postoperative period, necessitating an early reintervention 10 days after the initial repair (*Figure 5*). In this case, the patch was reattached. The repair lasted for 8 years, after which calcification of the valve necessitated its

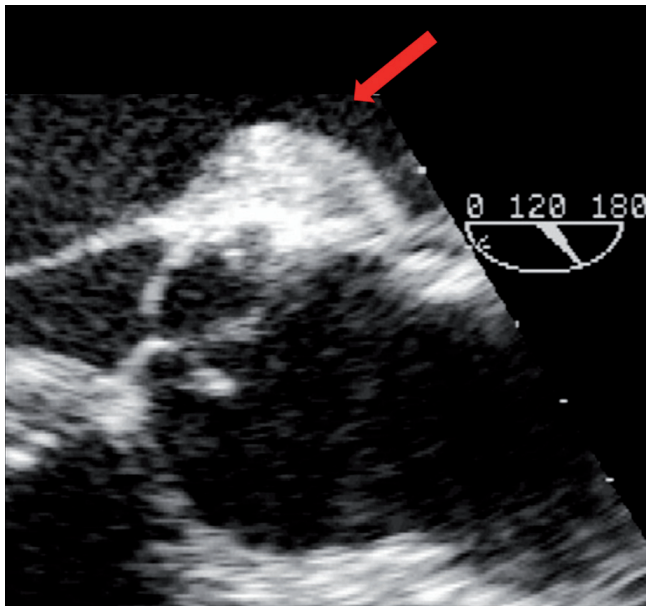
**Figure 7** Transesophageal echocardiographic midesophageal aortic valve long-axis (ME AV LAX) view showing swelling of the posterior aortic wall after aortic valve repair (red arrow). This could be due to edema or a hematoma and usually resorbs after a few days

The proximal suture of either a prosthetic valve, a subcommissural annuloplasty (SCA) or a tube graft at the level of the VAJ sometimes causes a posterior hematoma that usually resorbs after a few days (*Figure 7*).

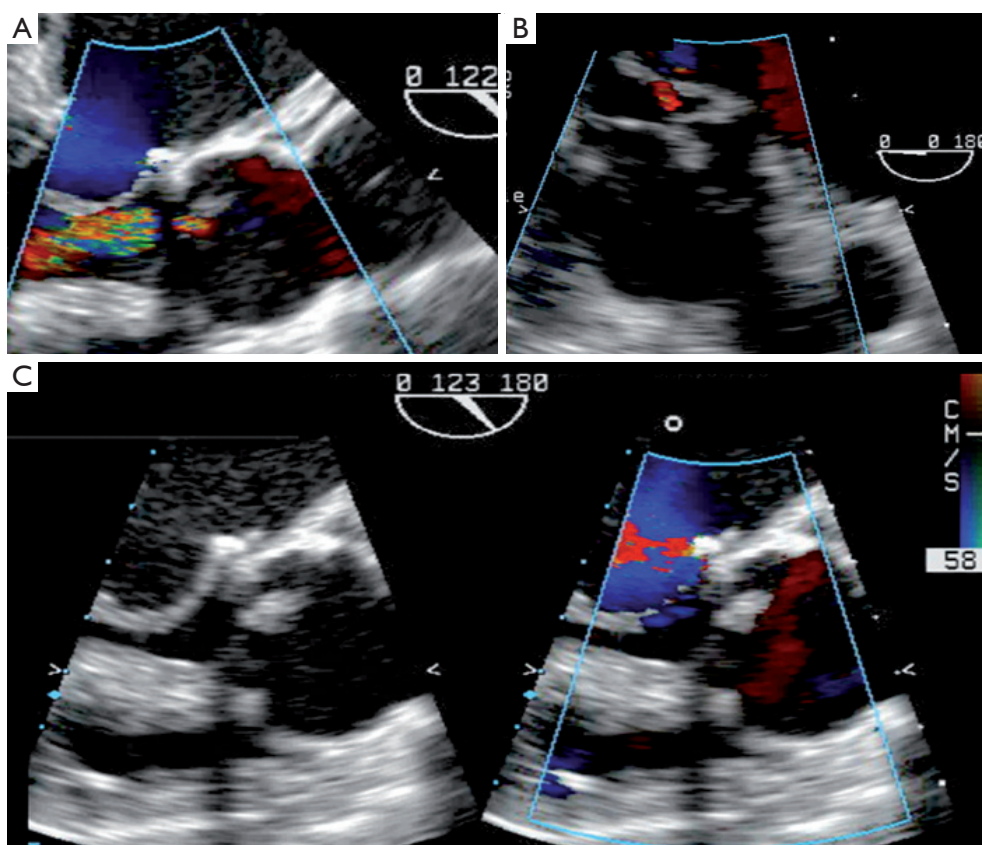
**Figure 8** Repair of a rheumatic tricuspid aortic valve associated with mitral and tricuspid valve repairs. Aortic surgery consisted of shaving of the free margins of the 3 cusps and 2 subcommissural annuloplasties (SCA) between the non-coronary cusp (NCC) and the left coronary cusp (LCC) and between the NCC and the right coronary cusp (RCC). (A) Transesophageal echocardiographic midesophageal aortic valve long-axis (TEE ME AV LAX) view with color Doppler showing an unsatisfactory result with moderate residual aortic insufficiency (AI). (B) Transesophageal echocardiographic transgastric long-axis (TEE TG LAX) view with color Doppler and (C) ME AV LAX view: after an additional annuloplasty stitch placed lower in the same 2 intercommissural triangles, the coaptation is good and the valve shows only trivial AI

Subcommissural annuloplasties (SCAs) are felted sutures applied at the mid-level of the intercommissural triangles, with the aim of reducing and stabilizing the VAJ. These sutures can also help to increase cusp coaptation (*Figure 8*).

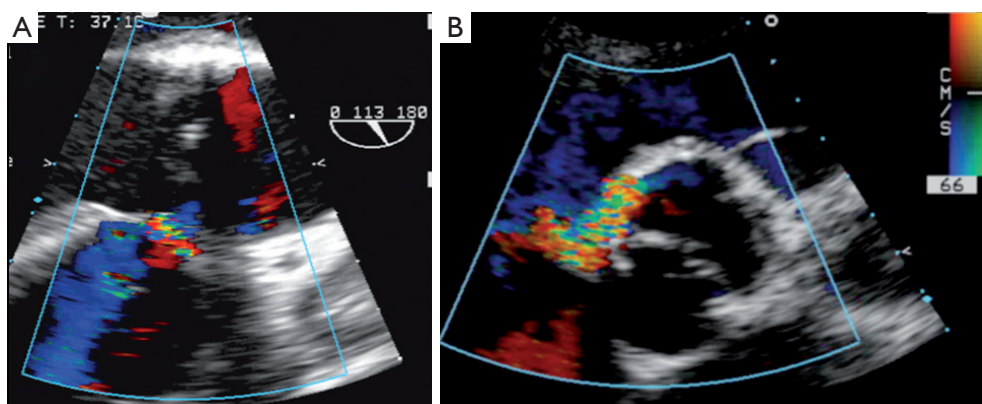
**Figure 9** Fistula between the aorta and the right ventricle after bicuspid aortic valve repair. This complication was caused by the subcommissural annuloplasty (SCA) stitch placed at the anterior commissure and was discovered at patient discharge on postoperative day 6. Midesophageal aortic valve long- (ME AV LAX) (A) and short- (ME AV SAX) (B) axis views with color Doppler on transesophageal echocardiography (TEE) performed at reoperation. Direct closure of the fistula with redo of the SCA was performed

SCAs can also provoke a tear or a fistula if the aortic wall tissue is abnormally fragile. A patient with bicuspid aortic valve presented with an aorta to right ventricle fistula at the anterior commissure 6 days after repair. At the immediate post-CPB intraoperative TEE the fistula was not observed, but at discharge transthoracic echocardiography disclosed a severe left to right shunt (*Figure 9*). The patient was immediately reoperated. The fistula was directly closed and the SCA redone.

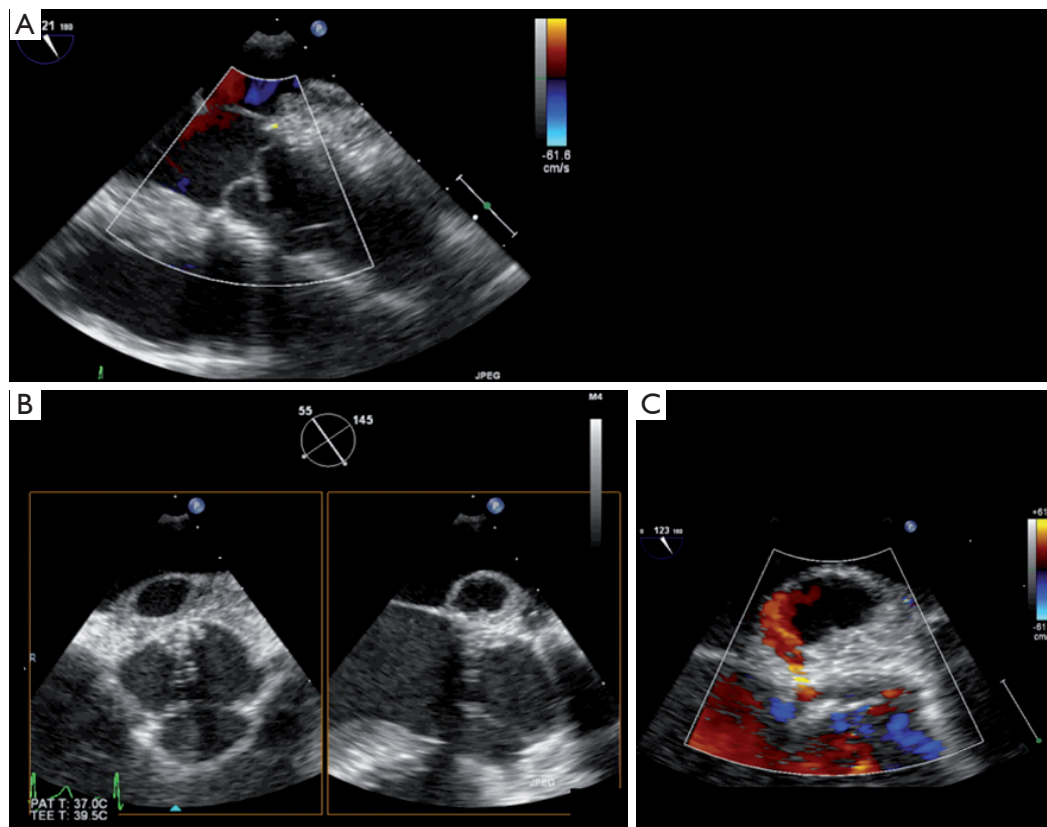
**Figure 10** Pseudoaneurysm caused by a tear in the aortic wall provoked by the subcommissural annuloplasty (SCA) stitch placed at the commissural triangle between the non- and the left coronary cusps. A. Immediate postoperative result with a posterior wall hematoma and no residual aortic insufficiency; B. A few minutes later, appearance of a growing pseudoaneurysm seen in two orthogonal planes; C. Midesophageal aortic valve long-axis (ME AV LAX) view with color Doppler showing the fistula that feeds the pseudoaneurysm. The rapid growth of the pseudoaneurysm prompted us to perform a reimplantation of the valve to exclude all fragile aortic tissues

A more severe complication of SCAs is the acute occurrence of a pseudoaneurysm. Such a pseudoaneurysm can rapidly increase due to a continuous flow from the ascending aorta

into the posterior aortic wall (*Figure 10*). We observed this complication in a case of tricuspid aortic valve repair. The surgery initially consisted of free margin plication associated with three SCAs. After unclamping, a rapidly-growing pseudoaneurysm was detected in the posterior aortic wall (non coronary sinus). At reopening of the aorta we found that the felt of the NCC/LCC SCA got through the aortic wall. Therefore we decided to perform reimplantation of the valve to exclude the abnormally fragile tissues of the aortic root.
